MISCELLANEOUS PAPER S-77-26

# OBSERVATIONS OF PORTLAND CEMENT CONCRETE AND POROUS FRICTION COURSE PAVEMENT CONSTRUCTION

Soils and Pavements Laboratory  
U. S. Army Engineer Waterways Experiment Station  
P. O. Box 631, Vicksburg, Miss. 39180

December 1977

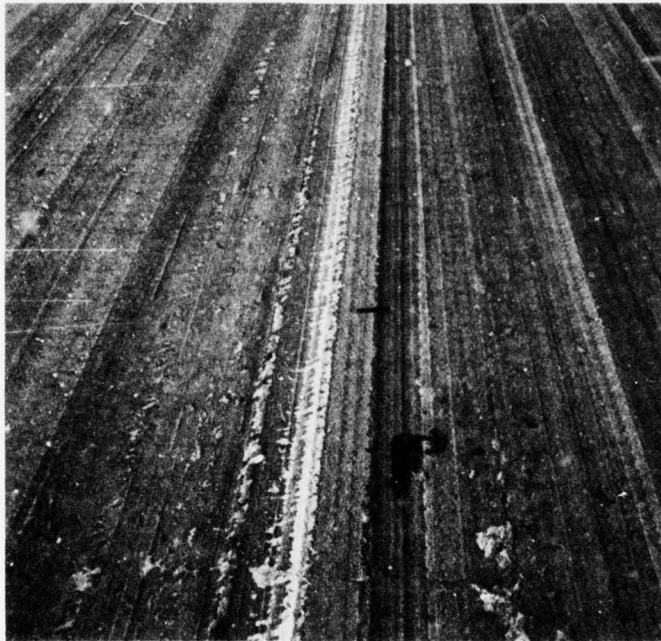
Figure 1. Rutted surface of soil cement

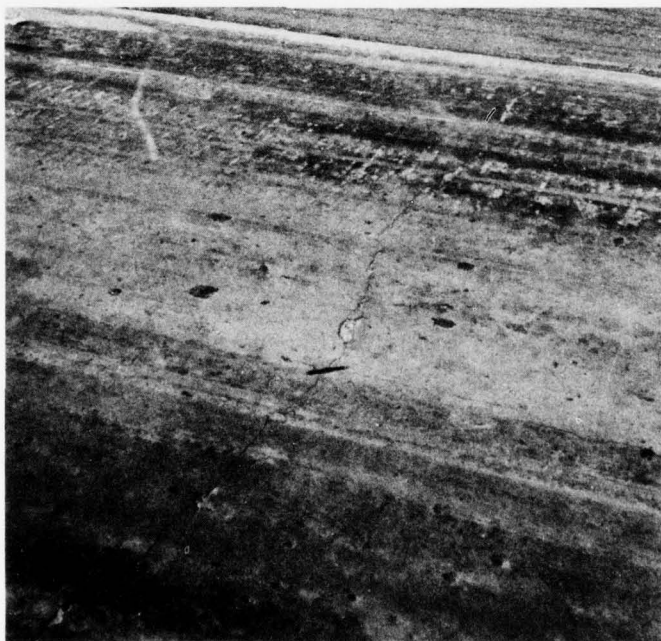
Figure 2. Shrinkage cracking of soil cement

- f. The cement-stabilized sand base was cracked about every 20 ft; however, from visual examination, it did not appear that the cracks were working extensively.

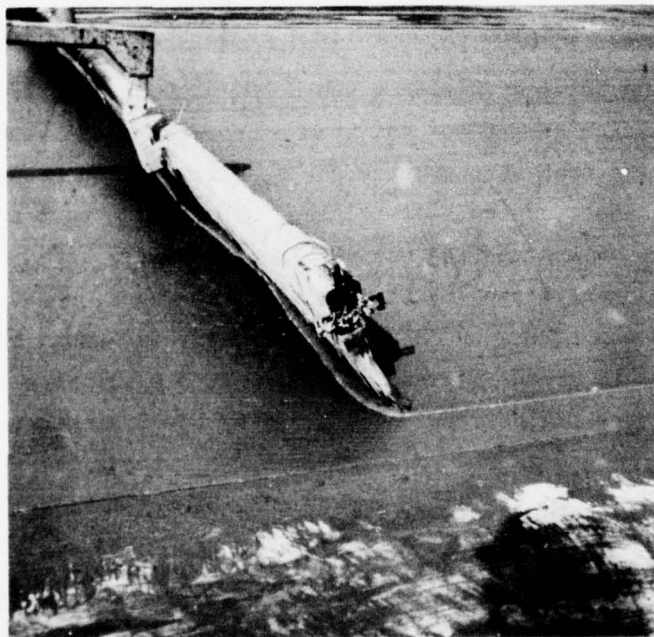
21. In the description of the initial visit it was noted that a brush was being used to texture the surface. This was now being used in the finishing operations. Tears and small depressions were being formed in the surface, and the brush was being used in conjunction with the tube float to move mortar around on the surface to fill these tears and depressions (Figures 13 and 14). The brush was moved back and forth several times over the surface, rather than only one time which is all that is necessary for texture application, and considerable mortar resulted as shown in Figure 14.

Figure 14. Closeup view of brush applying  
finish texture to pavement

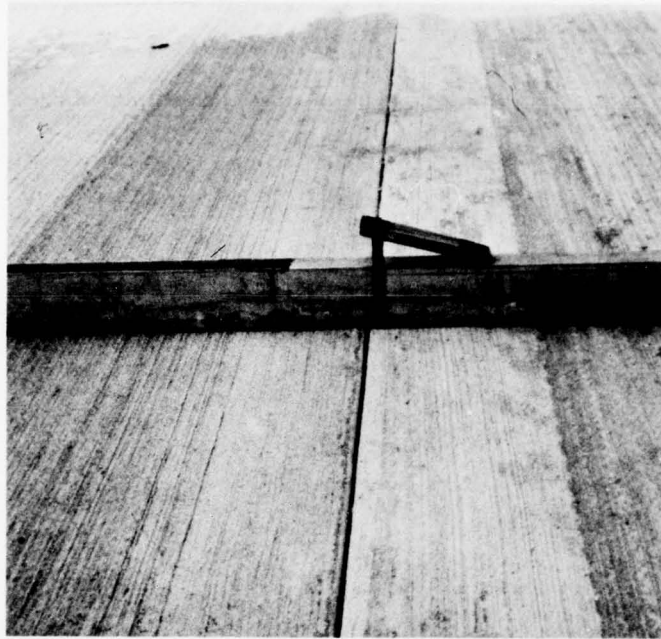
Figure 18. Typical shape along longitudinal construction joints (ridge along fill-in edge)

The observed profiles of the surface along longitudinal construction joints emphasize the need for caution concerning hand finishing of edges. The use of the brush for finishing the surface is a questionable practice because of the large amount of mortar that results. Although the conclusion that hand finishing is a satisfactory method for compensating for edge slump is valid, it should be noted that overcompensation can negate any benefits derived from eliminating edge slump.

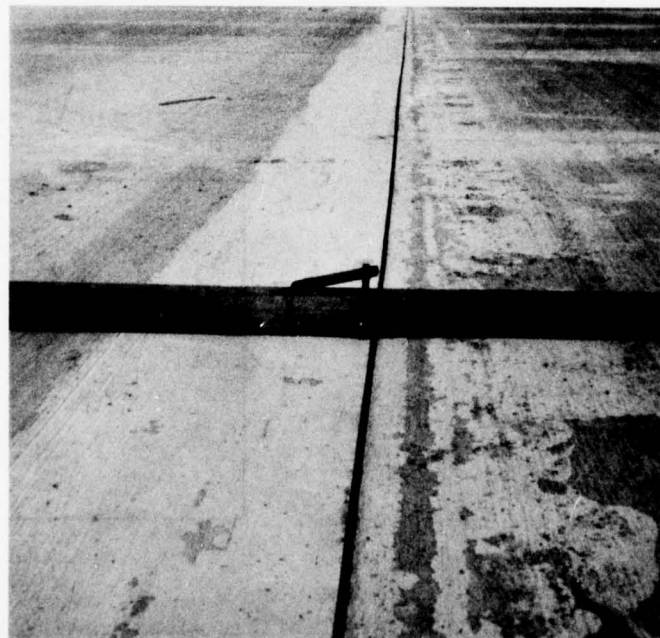
Figure 19. Typical shape along longitudinal construction joints (fill-in lane flatter)

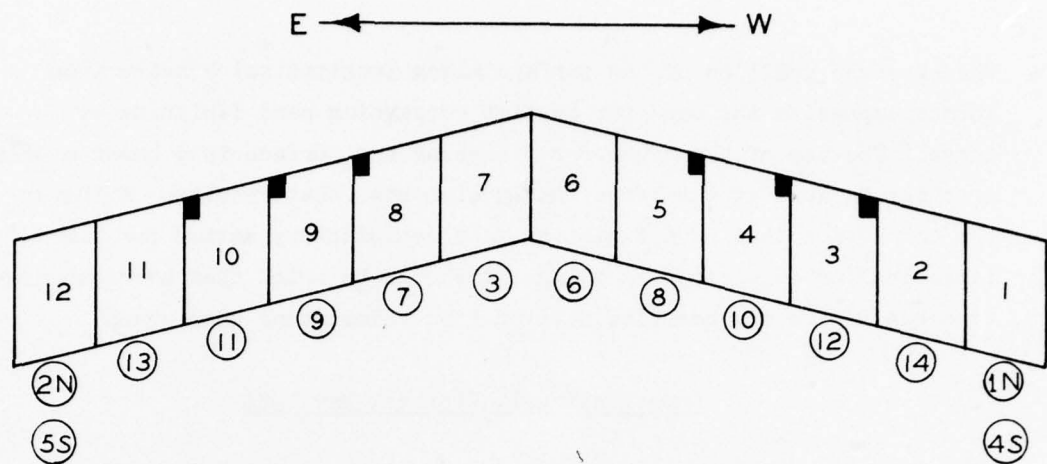
Figure 20. Construction sequence and location of spalling

31. The inspection performed on 4 May 1976 confirmed the condition observed in the CE Project Engineer's survey of March 1976. Scaling was limited to the slip-formed edge of paving lanes 3, 4, 5, 8, 9, and 10 as shown in Figure 20. No scaling was noted along the slip-formed edges of paving lanes 1, 6, 7, and 12 or along the edges of fill-in lanes 2 and 11. Nor was any scaling noted along either slip-formed or fill-in edges of the ungrooved apron and tow-way pavements. The scaling had occurred randomly along the edges and in random lengths ranging from a few inches to several feet. The depth of the scale varied from paper thin at the edge to a maximum of about 1/4 in. and generally feathered out 4 to 8 in. from the edge. The scaled material was a sand-cement mortar containing no coarse aggregate. The surface exposed by the scaling was very smooth with a characteristically different color (lighter) from the scaled material. A scraping device had been used to remove weakened mortar material that had not been dislodged by the groove-sawing operation. However, additional mortar material could be broken loose with a knife blade or by tapping on the surface with a steel rod. Tapping with a steel rod confirmed that the condition leading to the scaling is probably random, because sound concrete could be detected at the boundaries of the scaled areas. Particular attention was paid to the unscaled edges of the runway and apron; however, tapping with the steel rod did not reveal any conditions (hollow sound or crushing of the mortar surface) that would indicate a potential for future scaling. Based upon the visual inspection, sounding of the concrete with a steel rod, review of material quality and handling techniques, and a review of construction practices, there is no reason to question the overall quality of the concrete pavement. All indications are that the scaling is a localized problem randomly located along a portion of the longitudinal joints.

- a. The scaling problem exists only on slip-formed edges indicating a relationship with slip-form construction procedures. Similarly, the fact that scaling has occurred only along edges of pavements that have been grooved indicates a relationship to the grooving operation. However, neither all slip-formed edges nor all edges that have been grooved have scaled, pointing to some other condition as the basic cause of scaling.

- b. The random occurrence and the general configuration of the scaled areas strongly suggest that the scaling is associated with the hand working along the edges to compensate for slumping of the unsupported plastic concrete. There are two facts that are considered pertinent. First, the depth of the scaled areas rarely, if ever, exceeded 1/4 in. (the maximum amount of edge slumping permitted by the job specifications without a reduction in pay). Therefore, either the total amount of slump exceeded 1/4 in. and the repair was to bring the edge back to specification limits without a reduction in pay or if the initial slump was 1/4 in. or less, the repair was made primarily to simplify finishing of fill-in lanes to be placed later. The second pertinent fact is the absence of scaling in the initially placed lanes on the runway. This suggests that either the requirement to build up the slumped edge to meet specification requirements was more rigidly enforced in the latter lanes or the contractor realized that finishing operations on lanes abutting in-place lanes were simplified if the edges of the in-place lanes were built up to specified grade (no slump). In either case, it appears that there was more effort applied to repair or build up the edges of the slip-formed edges after completion of the first four or five paving lanes. This could have resulted in more handworking of the edges which increased the likelihood of excessive mortar buildup and/or late edge finishing which resulted in a weak edge condition. The aggressive sawing action then caused the weakened-edge condition to scale.

33. Based upon the inspections, review of construction practices, and information regarding materials quality and handling techniques, it is concluded that the scaling is related to, but not directly caused by, the slip-form or groove-sawing operation. Rather, it is probably the result of one or more of the following:

- a. Excessive and/or late handworking of the slip-formed edges to compensate for excessive slumping of the unsupported plastic concrete behind the slip-form paver. Excessive working of the edges can cause displacement of the coarse

aggregate leaving a poor quality mortar surfacing which does not exhibit sufficient strength to withstand aggressive loading such as the groove-sawing operations. Improper use of the tube float and repeated passes of the broom for applying surface texture also result in concentration of weak mortar along longitudinal construction joints. The late repair of slumped edges results in the application of a mortar material to the concrete after it has experienced its initial set. This results in a weak bond between the concrete and mortar surface which cannot withstand aggressive loadings.

34. The groove-sawing operations produced an aggressive action which caused a separation of the mortar surfacing from the underlying concrete along the joints. Whether the scaling would have occurred had the pavements not been grooved is open to conjecture. Considering the relatively low strength of the spalled mortar material and the low bond strength between the mortar and concrete, it is probable that some scaling would have occurred due to stresses created by wheel loadings and/or climatic changes. Certainly, the integrity of the edges would be suspect in more aggressive climates where freezing and thawing of the pavements would occur. While not as severe, repeated wetting and drying of the concrete surface will cause stresses which, when added to wheel load stresses, may create conditions that exceed the mortar and/or bond strength. Considering these possibilities, it is probable that some additional scaling will occur randomly along the longitudinal joints including the joints in pavements that have not been grooved. The amount of any longitudinal scaling cannot be determined. It may be possible to better quantify the amount by tests of the concrete integrity along the joints. Meanwhile, it is felt that the major portion of scaling that will occur on the runway has already taken place during the groove-sawing operation. While some additional scaling may occur, it will probably be less than has already occurred and it should happen at a relatively slow rate.

- c. If the scaling is determined to be an operational problem or for other reasons it is desirable to repair the scaled edges, such repairs can be made using either an epoxy bonded PCC or epoxy concrete patches. It will first be necessary to carefully determine the scaled and potentially scalable areas using either (1) visual examination, (2) the solid-rubber-tired or steel-wheeled traffic mentioned in b above, or (3) a Schmidt hammer, or a "sonoscope" as will be discussed in the following paragraphs. After delineation of the areas to be repaired, it is recommended that the repairs be made with epoxy mortar or concrete.

- e. Unless the scaled areas present an operational problem it is recommended that no repairs be attempted at this time. It is believed that the scaling will cease and that the pavements will function properly from a structural standpoint. Additional scaling may require some housekeeping in the form of vacuuming and sweeping to remove debris from the surface.

- f. If it is determined that the scaling presents an operational problem, it is recommended that the potentially scalable areas be delineated and repaired by cutting and chipping out about 1- to 2-in. depth of concrete along the edge and patching with an epoxy concrete material.

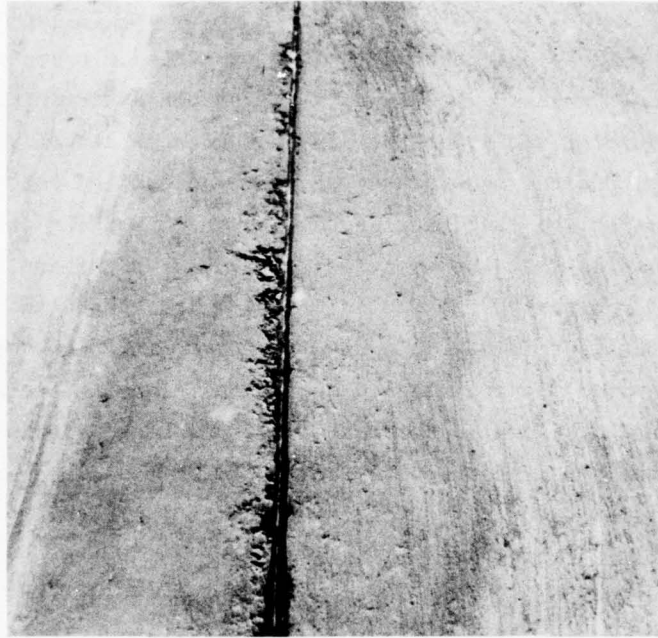
55. Observations of the sawed joints revealed only minimal raveling and spalling and no uncontrolled cracking. The joints formed with the Unitube on the taxiway were observed. There was some evidence of spalling and handwork around the inserts (Figures 31 and 32). It was impossible to get the inserts in place without disturbing the surface which requires hand finishing to correct and which results in unevenness in the surface near the inserts. The project engineer indicated that he preferred sawing because of the necessity for hand finishing around the inserts. The system used for stabilizing the dowels apparently worked well since visual observations of the dowels indicated adequate alignment.

Figure 31. Spalling adjacent to Unitube inserts

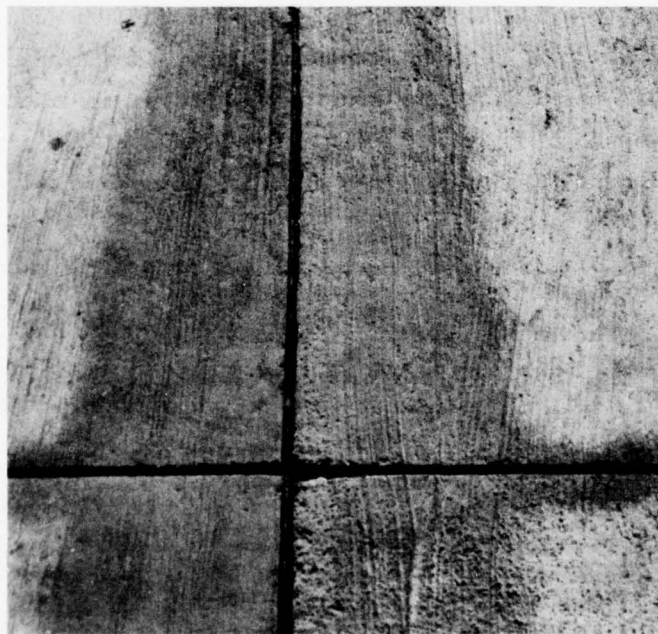
Figure 32. Evidence of hand finishing  
adjacent to inserts

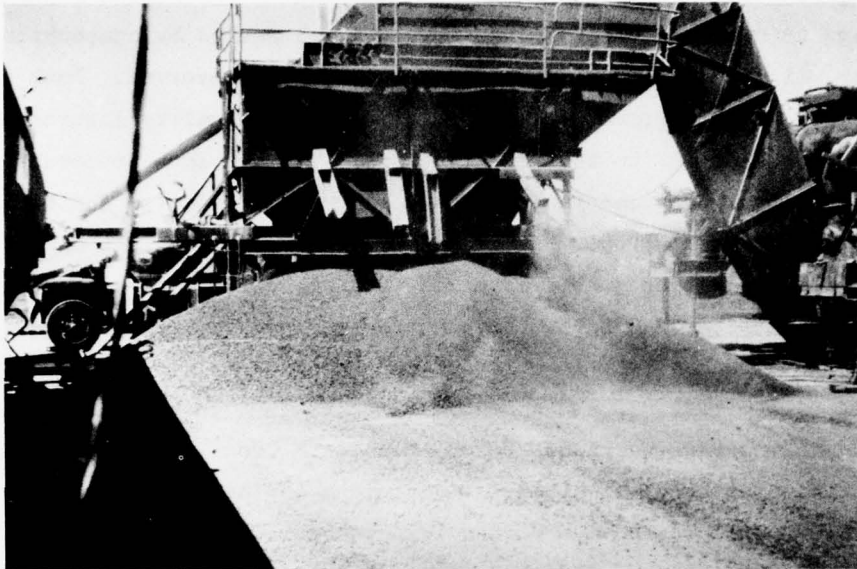
71. As mentioned previously, the cold feed facilities at the asphalt plant located on a taxiway adjacent to the construction site, were limited; consisting of three bins and one silo. Two of the cold bins were used for the 5/8- to 1/2-in. size aggregate and the minus 5/8-in. aggregate, respectively. The third cold bin was used for the blended manufactured and natural sands. The silo was used to feed the blended limestone dust and hydrated lime. There seemed to be a lack of information concerning calibration of the cold feeds, but this procedure was not observed because construction was already in progress when the site was visited. The asphalt plant screening unit had 5/8- and 1/8-in. screens. There was poor balance between the cold feeds and material being pulled from the hot bins as is depicted in Figure 33 by the overflow from the asphalt plant hot bins.

Figure 33. Hot-bin overflow
